A/T - Solenoid Valve Replacement Procedures

Classification: AT96-010 Reference: NTB96-110

RE4F04A AND RE4F04V AUTOMATIC TRANSMISSION (A/T) - SOLENOID VALVE REPLACEMENT PROCEDURES

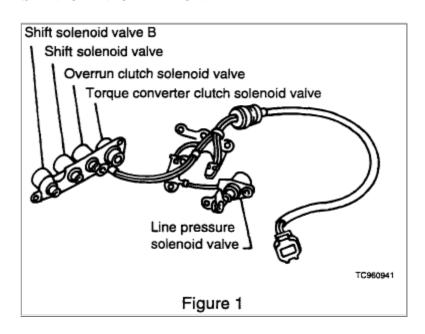
The RE4F04A and RE4F04V A/T are equipped with five solenoid valves as shown in Figure 1. Perform the Service Procedure whenever the solenoid valve assembly is replaced.

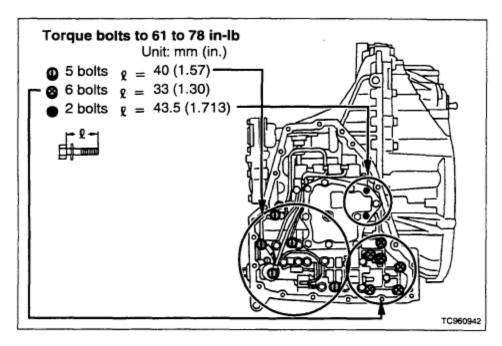
Figure 2

CAUTION: The control valve assembly must be removed prior to removing the solenoid valve assembly. If the solenoid valve assembly is replaced without removing the control valve assembly the transmission will develop unusual shifting.

1. Remove the thirteen, 10 mm bolts holding the control valve assembly to the transmission. Remove the control valve assembly (Figure 2).

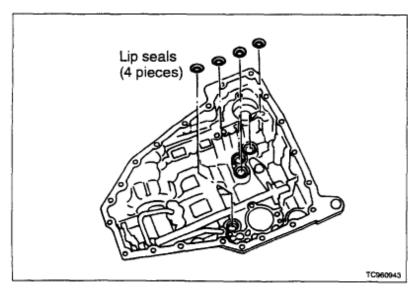
Figure 3

CAUTION: The four 0-rings (lip seals) behind the solenoid valve assembly must be reinstalled to their original locations. Out-of-position or cut lip seals will cause unusual shifting incidents.

- 2. Remove the two solenoid valve assembly retaining bolts and remove the solenoid valve assembly.
- 3. Install the new solenoid valve assembly into the control valve assembly.
